**TEWKESBURY TOWN COUNCIL
BUILDINGS & MOORINGS COMMITTEE
TUESDAY 30TH MAY 2023**

Town Hall, Tewkesbury

condition survey of the
external fabric
report number 2
April 2022

condition survey of the
external fabric
report number 2
April 2023

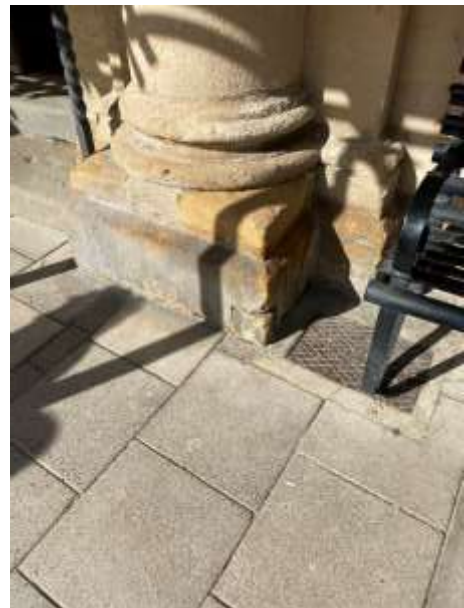
Column base right-hand side of entrance doors.

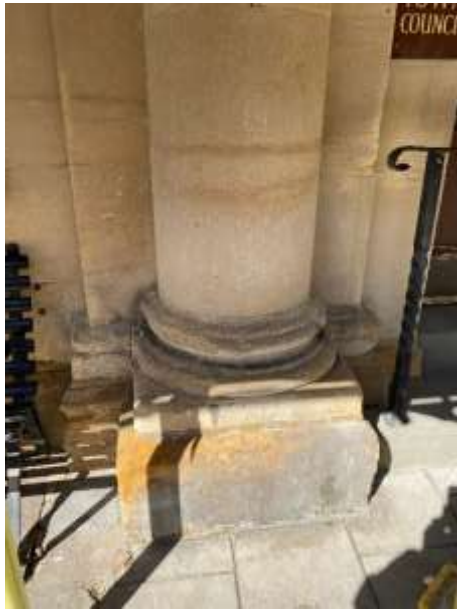
Column base left-hand side of entrance doors.

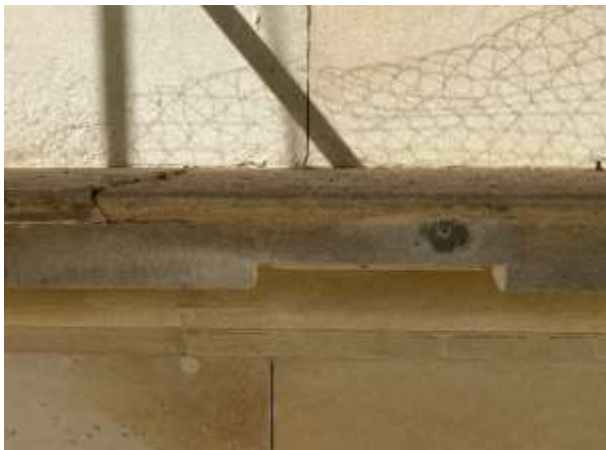
Corn exchange east wall stone repair 2 in progress.

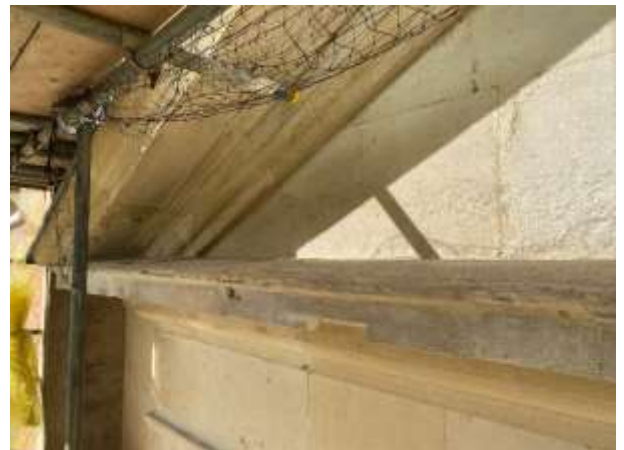
Corn exchange east wall stone repair in progress.

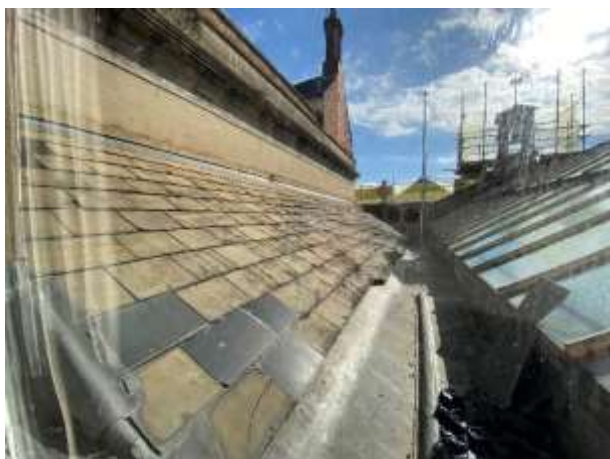
Corn Exchange north aisle roof.

It was noted that the north lean-to has had several slates replaced, one over-wide, and a couple appear to have been set in place with silicon, which is not recommended. Below this section of roof the plaster ceiling above the corn exchange is flaking and this may be due to past or current water damage.

Four of the lead valleys on the north side have fatigue cracks, which may be due to over-fixing. These can be patch repaired to improve the lifespan of the gutter, or ideally the four bays should be taken up and re-laid with min. code 7 lead.

Take up west section of north lean-to roof to a width of approximately 1.0m to repair broken slates and re-lay using slates to match and properly fixed with nails and tail rivets. **A**

Patch repair leadwork in north valley. **A**

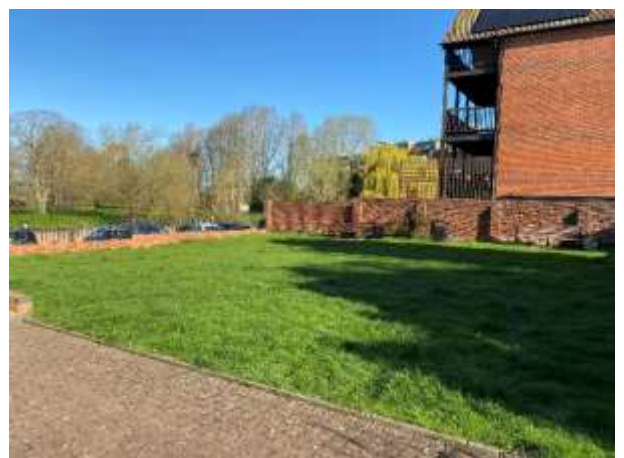
Gardens north boundary wall.

The earlier brick boundary walls of the Town Hall Gardens have many decayed bricks, open joints, and areas of inappropriate cementitious pointing and render. Plant growth is also evident on the southern boundary wall.

Cut out and replace all decayed brickwork with bricks to match. Take off all cementitious pointing and repoint walls in entirety with a lime mortar. This work is subject to listed building consent.

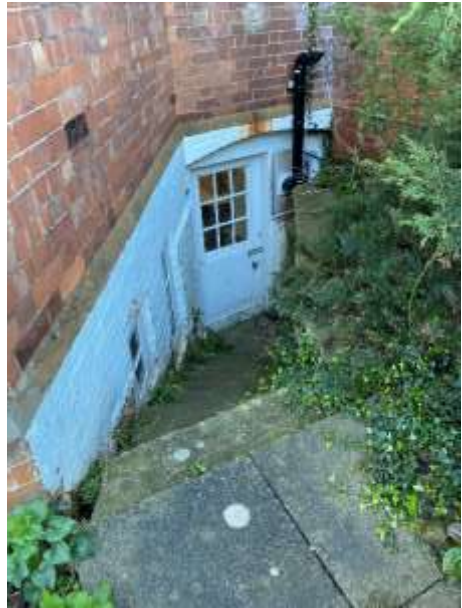
Basement steps.

Staircase to cellar has quite heavily worn treads.

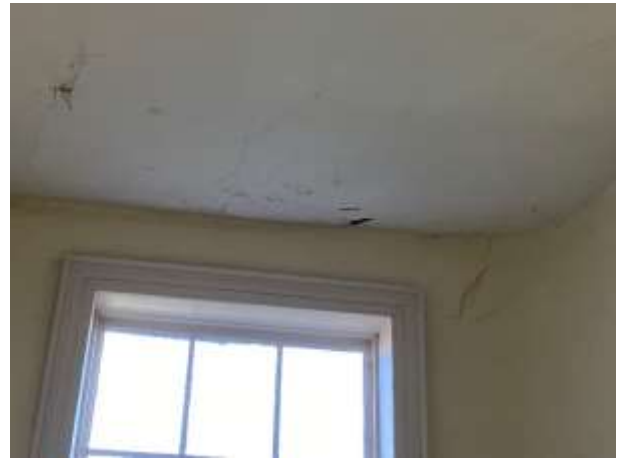
Town Hall stairwell ceiling.

Stairwell - plaster cracked at high level of north wall, above window (W15), in ceiling and above door (D28).

Remedial works to cracked and failing plaster, using a lime-based plaster, and redecoration with a breathable paint.
