**TEWKESBURY TOWN COUNCIL
BUILDINGS & MOORINGS COMMITTEE
TUESDAY 5TH MARCH 2024**

MECHANICAL AND ELECTRICAL BUILDING SERVICES CONDITION REPORT

Issue date: 22/07/2023

TEWKESBURY MUSEUM TEWKESBURY TOWN COUNCIL

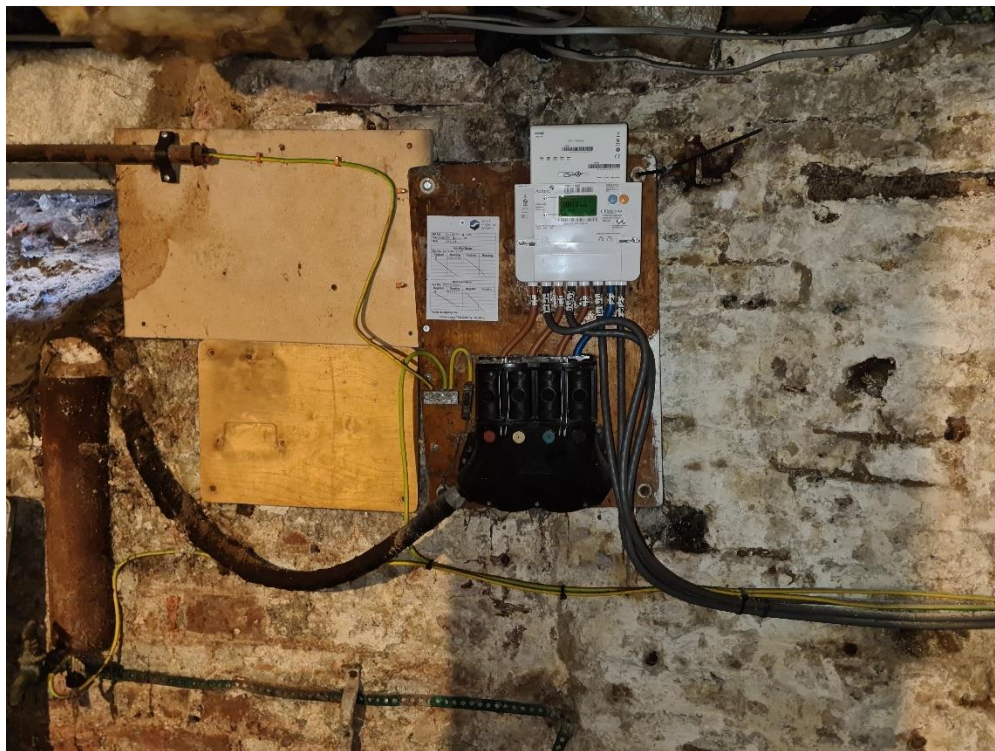
Figure 3 - Electrical Supply & Metering

The electrical supply cabling and cut out are in reasonable condition commensurate of age. It is assumed the supply and cut out was installed in the early 1980's. The metering equipment was replaced in November 2021.

It has been mentioned by the museum trustees that there is an ongoing issue with the incoming supply and power failures, more specifically with Phase 2 (black phase / old yellow phase). It appears this happens around 3-4 times per year but has happened only once in 2023 which was in April.

During our site survey, we could not find any evidence of damage or degradation to the incoming supply cabling or cut out equipment which would raise concern. However, it appears that the meter tails between the cut out and meter are showing signs of degradation. This cabling is double insulated and whilst we have no initial concerns, this should be monitored moving forward and cabling replaced should it degrade to a point where it poses a health and safety concern.

The customer should monitor the incoming supply cabling and cut out equipment and notify NGED should the condition deteriorate.

It is also recommended that National Grid Electricity Distribution are contacted regarding the resilience of the incoming supply and the regular failure on Phase 2.

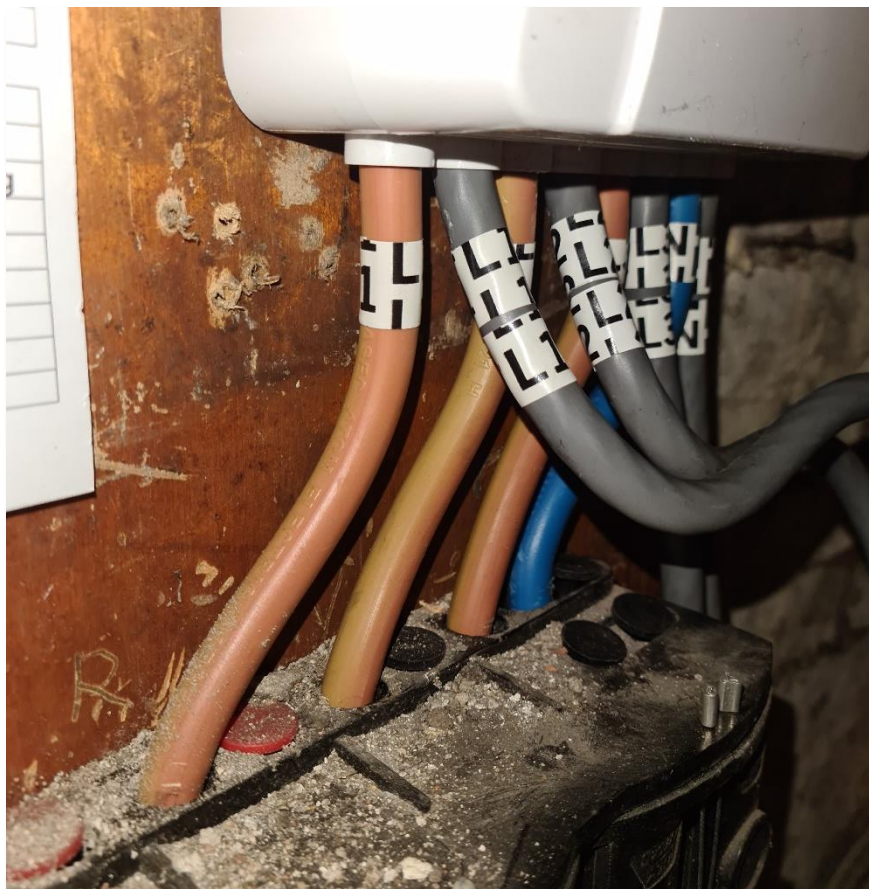
Figure 4 - Degradation of cable insulation below meter

The incoming supply arrangement should be visually inspected on a regular basis by a qualified electrician. Any damage found should be report to NGED immediately.

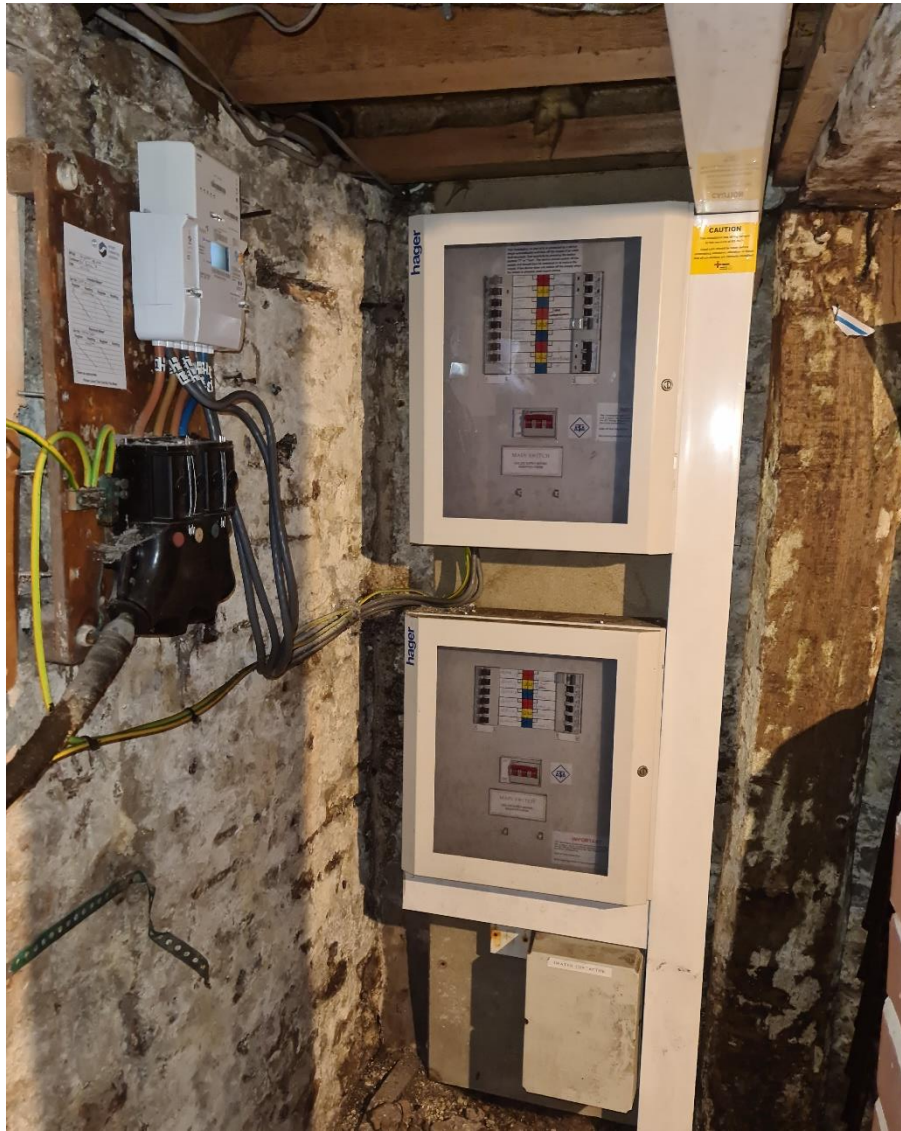
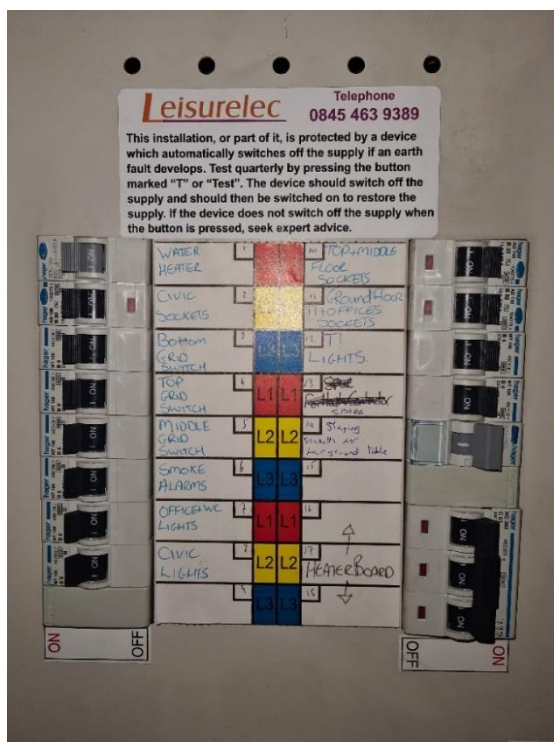
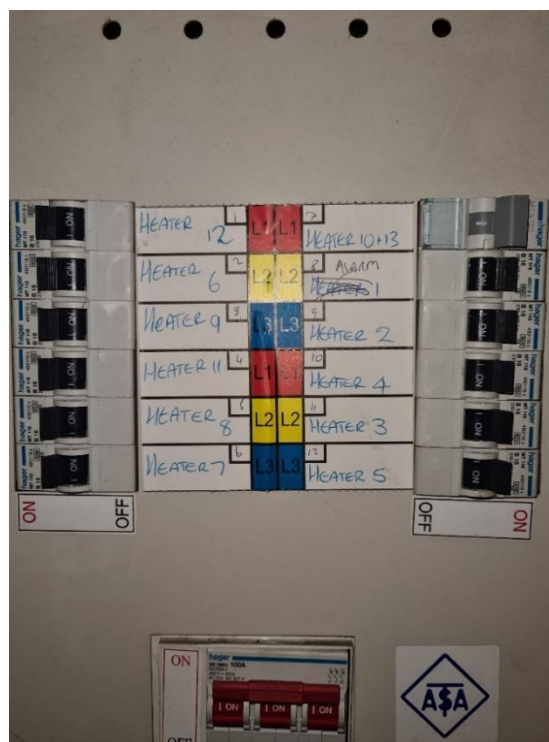
Figure 5 - Distribution Boards

The distribution equipment appears to be in good condition for its age. There is no visual damage to the equipment and all circuit protective devices are of the same manufacture as the distribution boards.

Due to the “Satisfactory” status on the last Electrical Installation Condition Report, the electrical distribution equipment is suitable for continued use in the short term. This should be reviewed after the next inspection in September 2025.

With reference to the below recommended actions, the installation of Arc Fault Detection Devices (AFDD) would cost approximately £100-150 per circuit. This would equate to approximately £2,800 - £4,200.

Due to the nature and construction of the building and the value of items contained therein, it is recommended that Arc Fault Detection Devices should be installed to each of the circuits as recommended by BS 7671.

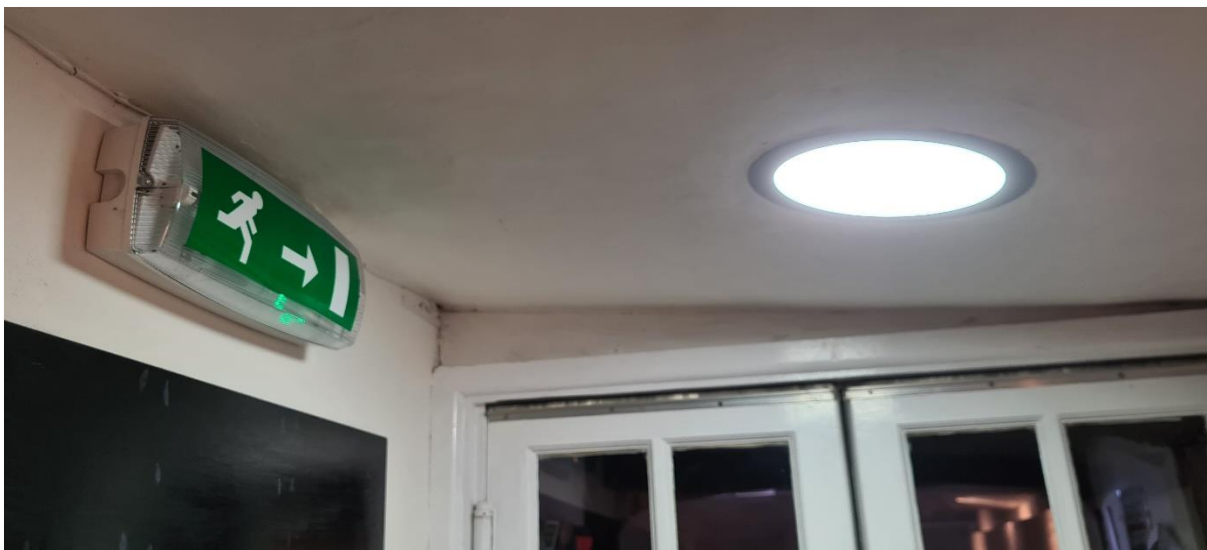
Emergency lighting is provided via standalone fluorescent bulkhead fittings with integral battery backup. From our initial survey we do not believe there is sufficient coverage of emergency lighting to all the required areas such as change of levels and direction, highlighting firefighting equipment etc (in accordance with BS5266).

Figure 8 - Example of emergency bulkhead and recessed LED fitting

Replacement of emergency bulkhead fittings - £50-70 per point.

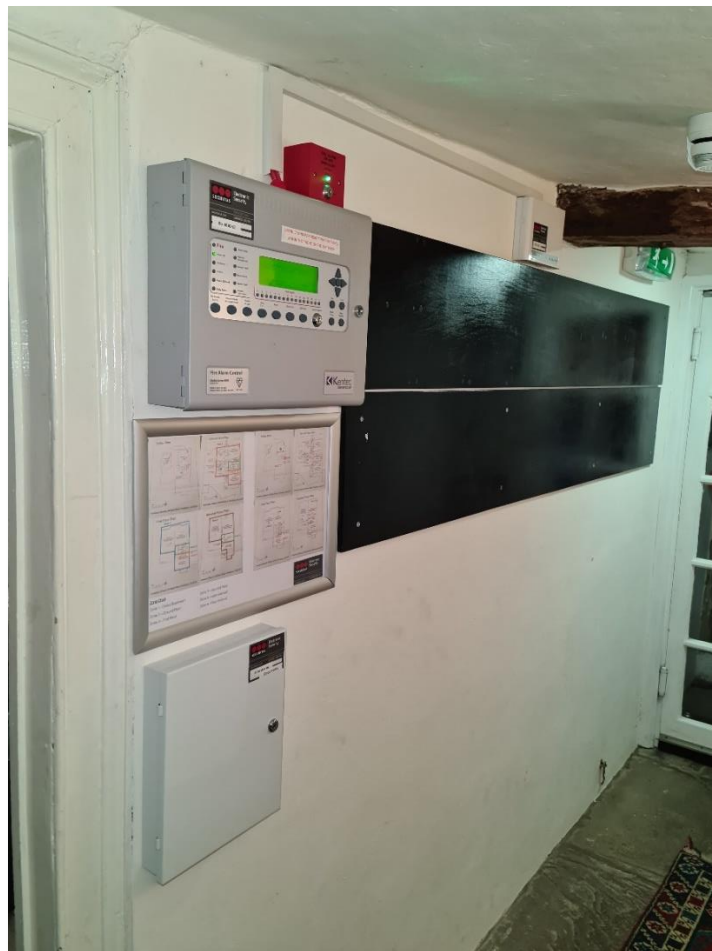
Figure 13 - Fire Alarm Control Panel, Zone Plan & Logbook

The fire alarm control panels were in good condition and there were no faults present at the time of the survey.

Securitas are the current maintenance provider for the fire alarm system, however, from conversations with the museum trustees, they do not appear to be providing sufficient service. It was also mentioned that a faulty manual call point was logged over a year ago with no replacement date identified.

Under current regulations it is recommended that weekly, monthly, and yearly tests and inspections are carried out to identify any faults and false alarms so they can be rectified to ensure a fully working and compliant system. Further information on the routine testing procedures can be found in BS 5839.

No maintenance programmes have been provided to ESC for review. These should be issued to ESC as soon as possible for review. This should include the cause-and-effect strategy.

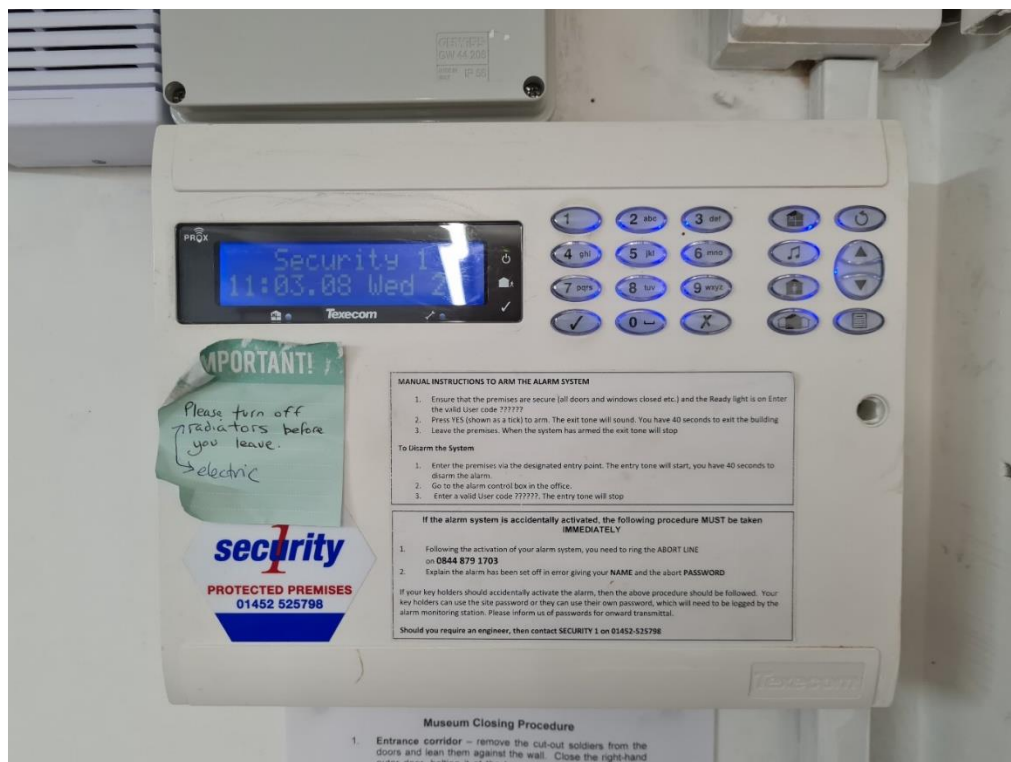
Figure 17 - Intruder Alarm Panel

Based on our site survey the system looks to be in good condition with no issues identified.

Based on the assumed installation date, some equipment has reached its life expectancy. However, as the system is annual maintained, this should be monitored moving forward and equipment replaced as required.
