**TEWKESBURY TOWN COUNCIL
BUILDINGS & MOORINGS COMMITTEE
THURSDAY 28th JULY 2022**

condition report
number 2
16 May 2022

tewkesbury museum, 64 barton street tewkesbury

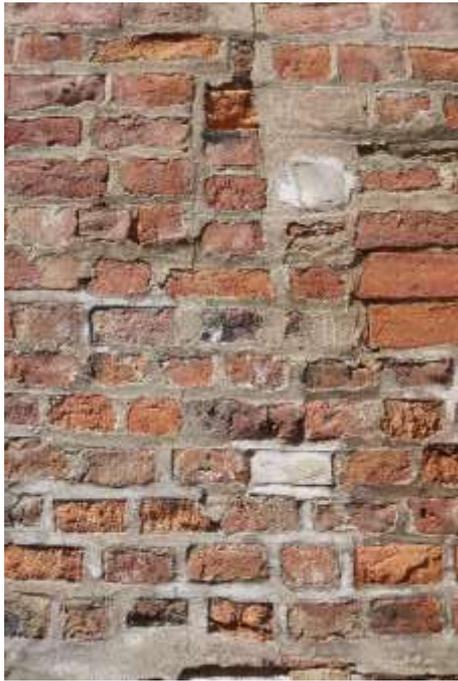
The brickwork of the south gable of the rear range is suffering from a past regime of cementitious repointing and damage will continue unless this is cut out and the brickwork repointed in a lime mortar.

South gable with dense cementitious mortar pointing.

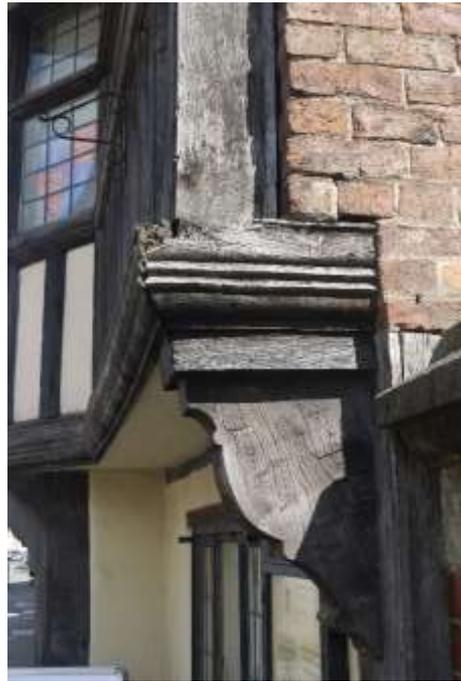
Moulded fascia at north-west corner – with decay.

The applied moulded fascia to the west and east returns on the north elevation at 1st floor level are rotten or missing.	Renew moulded fascia	3	18	m	£120.00	£2,160.00
		The painted timber fascia to the south and east elevations is in poor decorative order	Rub down and repaint fascia	3	18	m	£10.00	£180.00
	The south gable of the rear range has been rebuilt in brick	The re-pointing to the brickwork has been carried out in a dense cementitious mortar which is resulting in frost damage to the soft bricks	Rake out - all cement based mortar and repoint in a weak lime mortar	3	56	m2	£110.00	£6,160.00
Windows	Defective areas noted only	The window to the ground floor area is in poor decorative order	Rub down and repoint window	2	Item			£1,500.00
NORTH ELEVATION

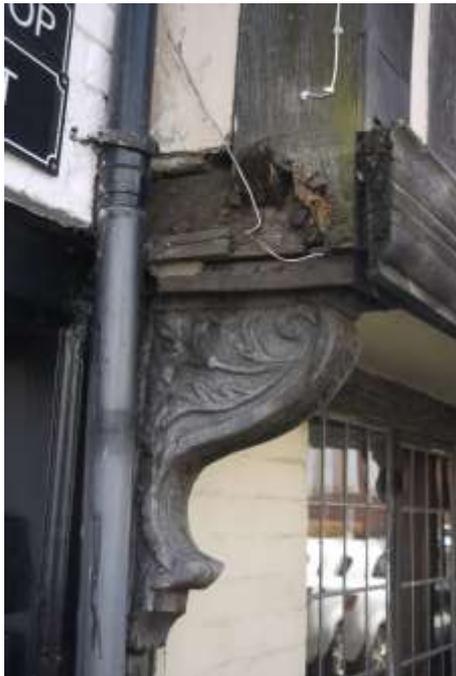
Missing moulded fascia north-east corner.

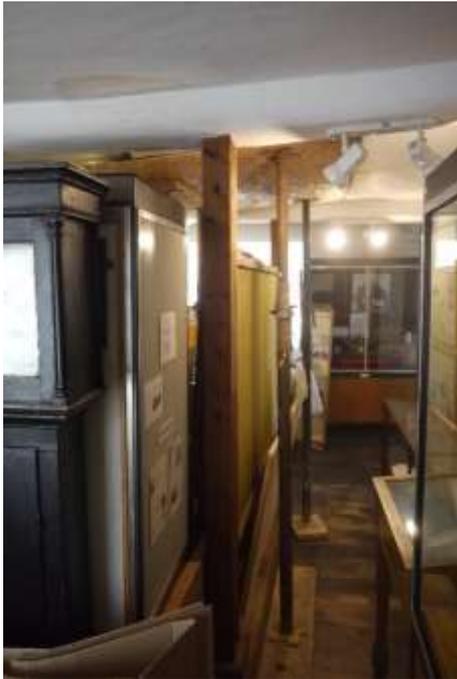
West exhibition room showing propping of ceiling.

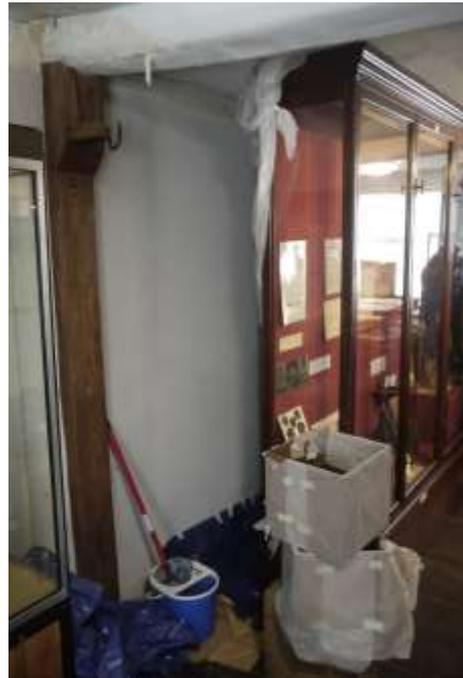
West exhibition room showing water ingress.

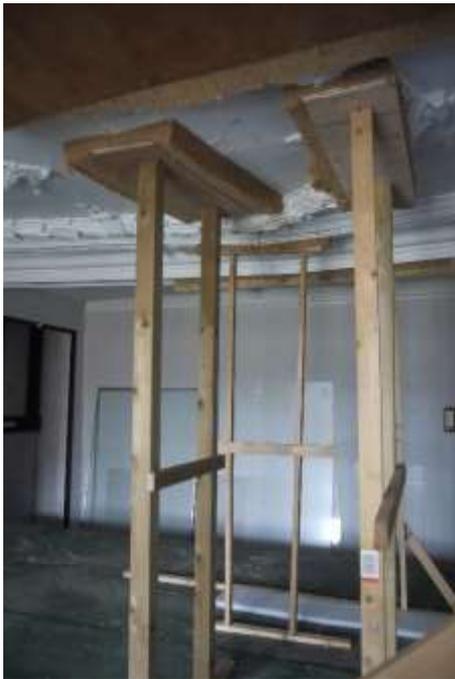
East exhibition room showing propping of ceiling.

Floor	part elm, part pine boarded	good						Nil
D9	oak panelled	good						Nil
EAST EXHIBITION SPACE								
Ceiling	lath and plaster with decorative plasterwork and cornicing	partially collapsed and in very poor condition. Evidence of water ingress. Ceiling now temporarily propped	detailed survey required by historic plaster specialist followed by conservation of ceiling	1	Prov Sum			£23,000.00
			<i>Overheads profit & attendances</i>					£4,000.00
Walls	plastered	some evidence of structural movement on S & E walls. Fair decorative order	monitor over next 12 months	MON	Prov Sum			£2,000.00
Floor	part oak, elm & pine boarded	good						Nil
D10	oak panelled	good						Nil
SOUTH ROOM (Archive store) including roof access area								
Ceiling	lath and plaster	good						Nil

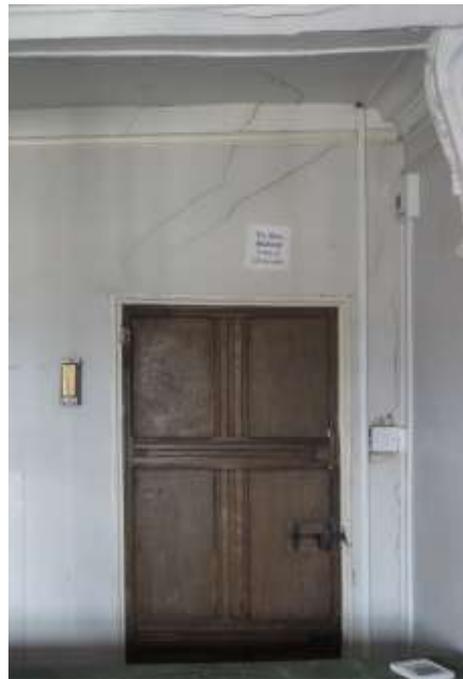
East exhibition room with evidence of past structural movement.

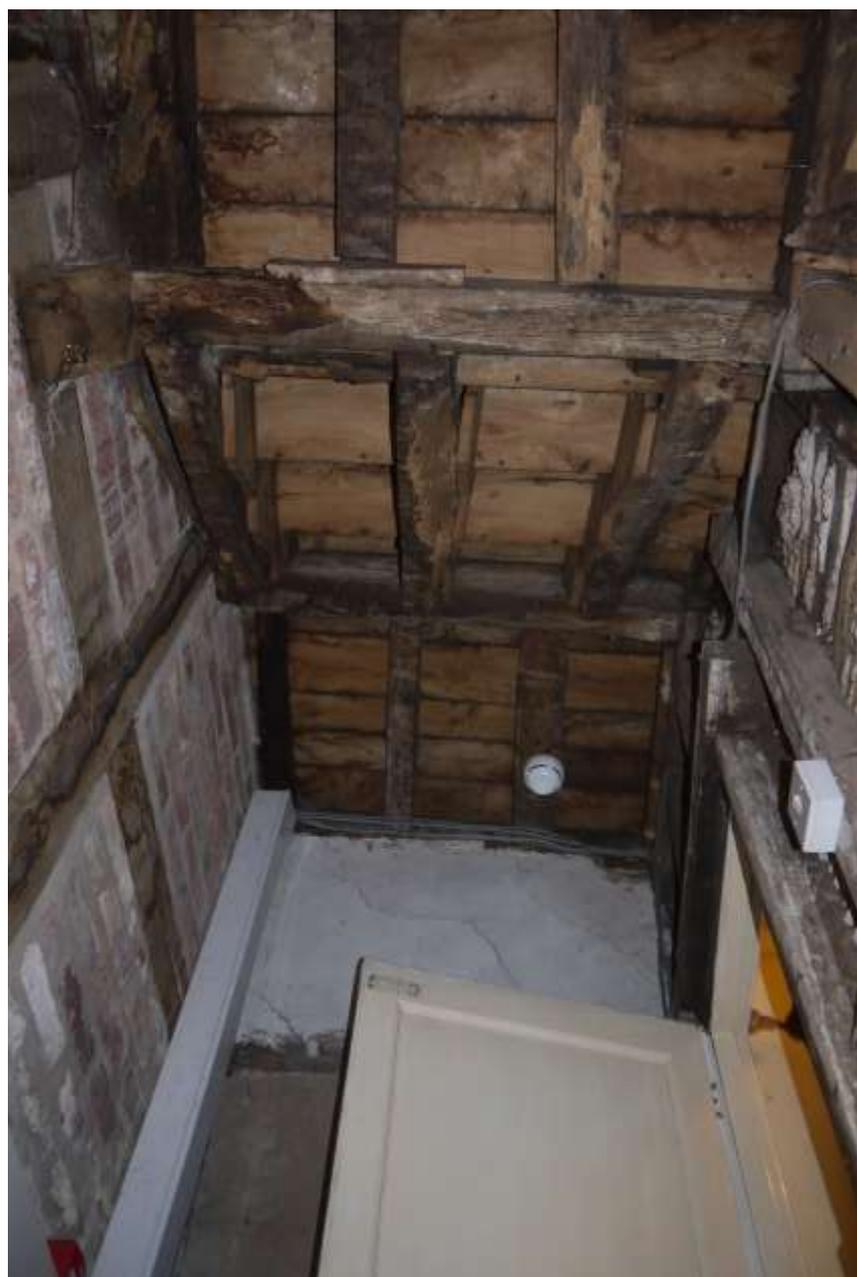
Main stair with no underboarding.

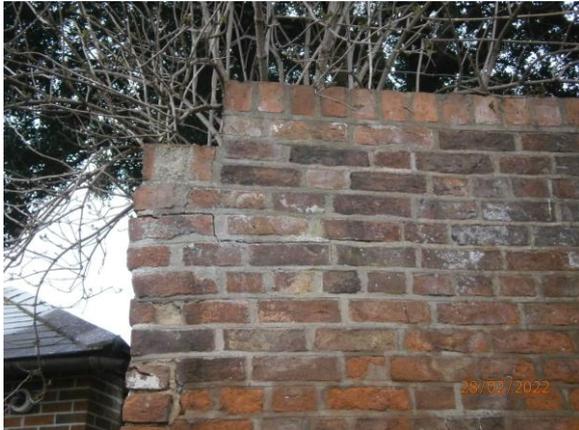
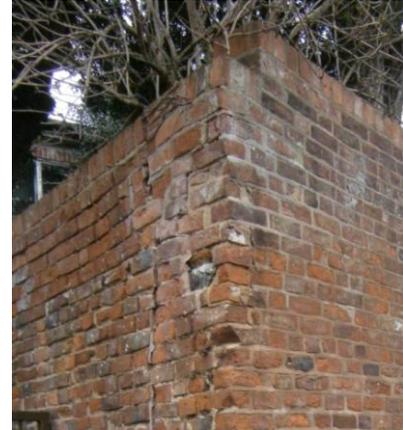
Defective Masonry Areas

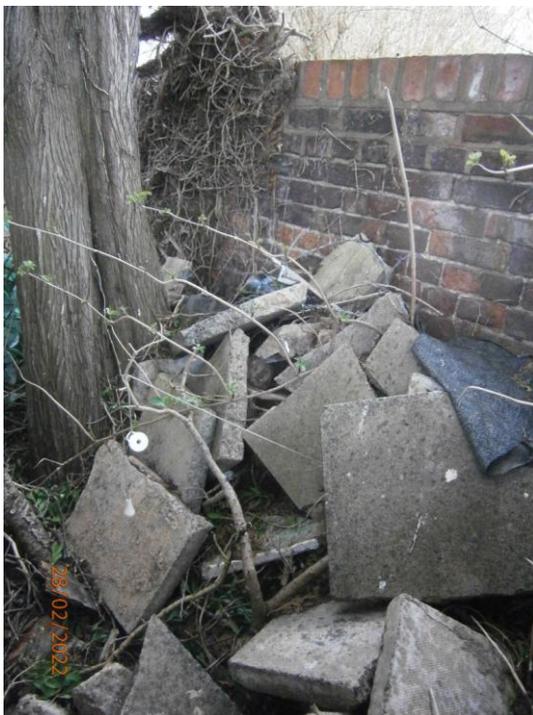
Build Up Paving Slabs
