**TEWKESBURY TOWN COUNCIL
BUILDINGS & MOORINGS COMMITTEE
TUESDAY 30TH MAY 2023**

Town Hall, Tewkesbury

condition survey of the
external fabric
report number 2
April 2022

condition survey of the
external fabric
report number 2
April 2023

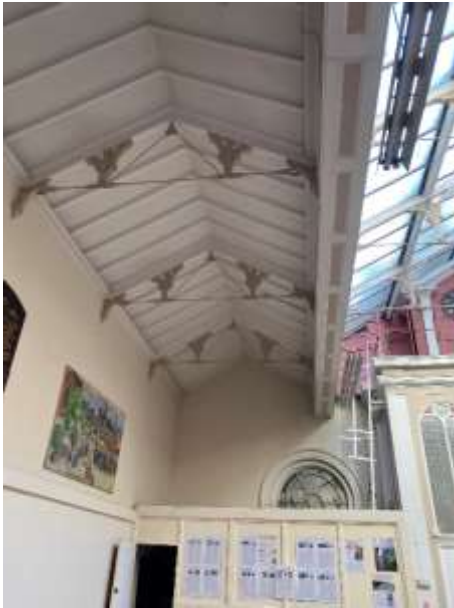
Corn Exchange north aisle roof.

It was noted that the north lean-to has had several slates replaced, one over-wide, and a couple appear to have been set in place with silicon, which is not recommended. Below this section of roof the plaster ceiling above the corn exchange is flaking and this may be due to past or current water damage.

Four of the lead valleys on the north side have fatigue cracks, which may be due to over-fixing. These can be patch repaired to improve the lifespan of the gutter, or ideally the four bays should be taken up and re-laid with min. code 7 lead.

Take up west section of north lean-to roof to a width of approximately 1.0m to repair broken slates and re-lay using slates to match and properly fixed with nails and tail rivets. **A**
